PHASE 1 REPORT FOR CONTAMINATION ASSESSMENT INVESTIGATION CHICORA
TANK FARM (CTF) CNC CHARLESTON SC
12/01/1988
NAVFAC SOUTHERN

PHASE I REPORT
CONTAMINATION ASSESSMENT INVESTIGATION

CHICORA TANK FARM

December 1988

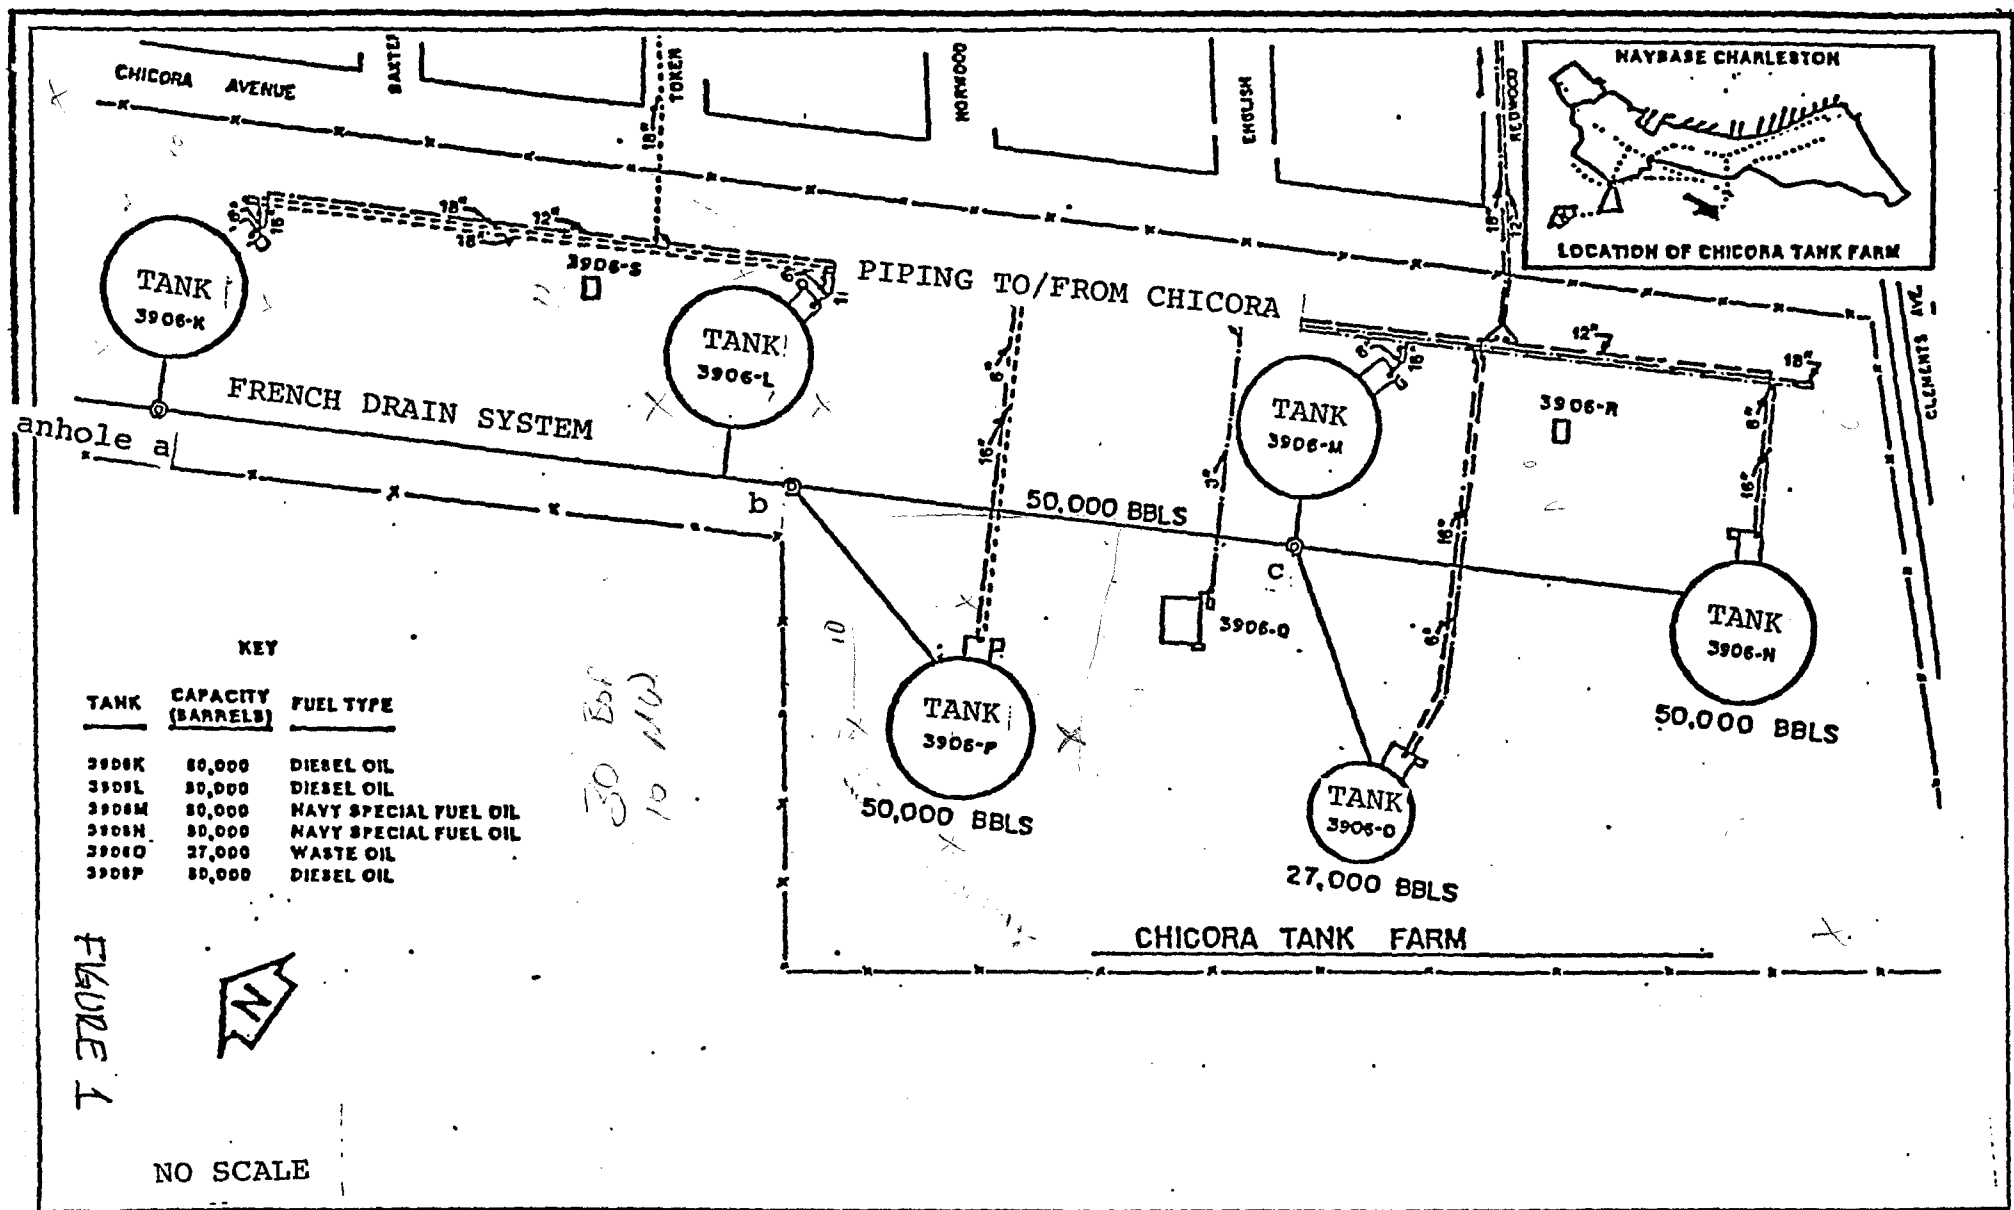
FIGURE 1

Currently tanks 3906-K, L, and P are used to store DFM and tanks 3906-M and N store NSFO. Tank 3906-O is used to store waste water and oil. The tank farm layout is shown in Figure 1.

CHICORA TANK FARM LAYOUT

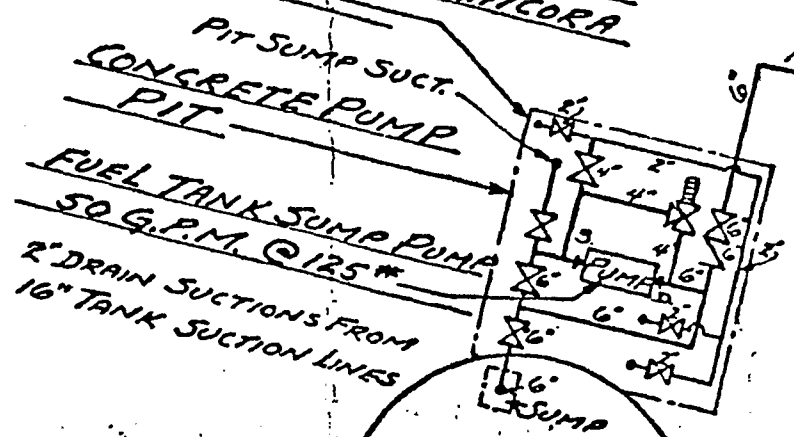
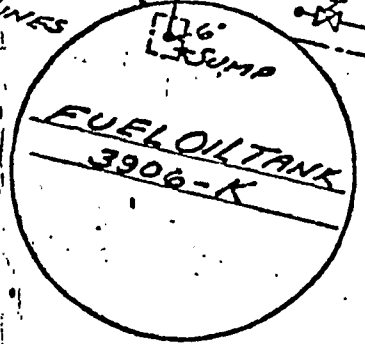
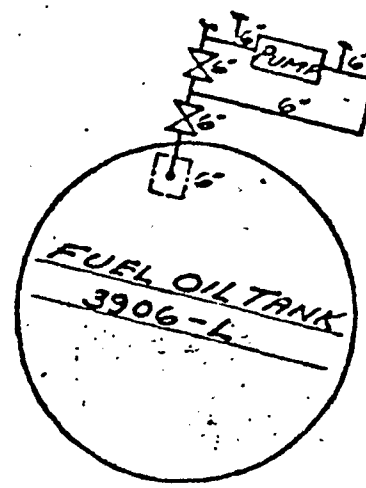
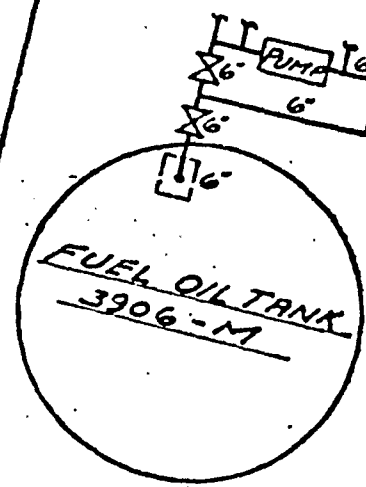
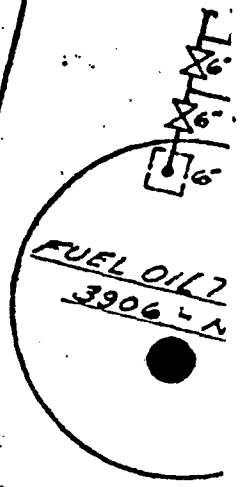
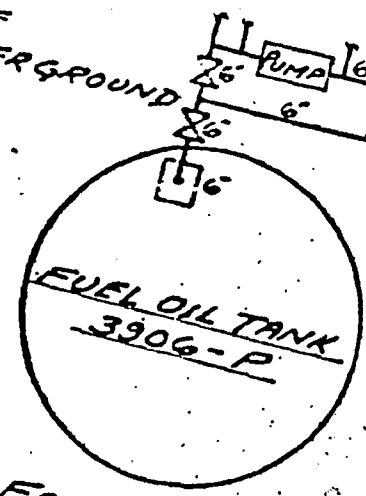
16" PUMP PIT PUMP & PIPING
SIMILAR FOR ALL SIX CHICORA
TANKS

NOTE:-
ALL CHICORA TANKS ARE
CONCRETE & ARE UNDERGROUND

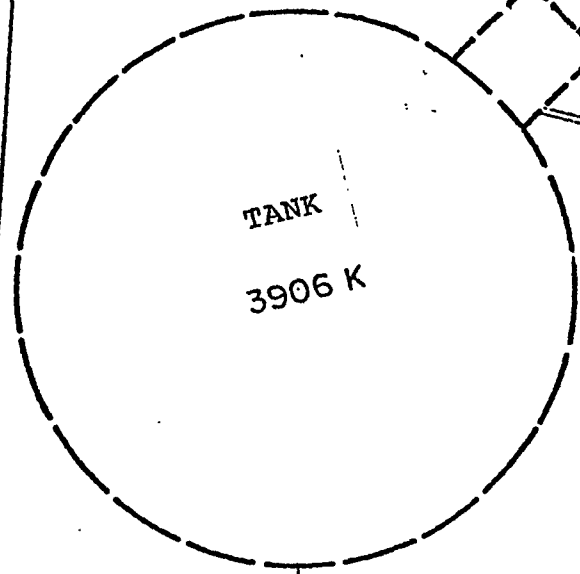
DIKE/SKIMMER SYSTEM

TANK
3906 K
